11 July 1969

MEMORANDUM FOR : Chief, WCFO

After testing the Advanced 918 Light Table Prototype and reviewing the specifications, we arrived at the following list of items to be modified or repaired.

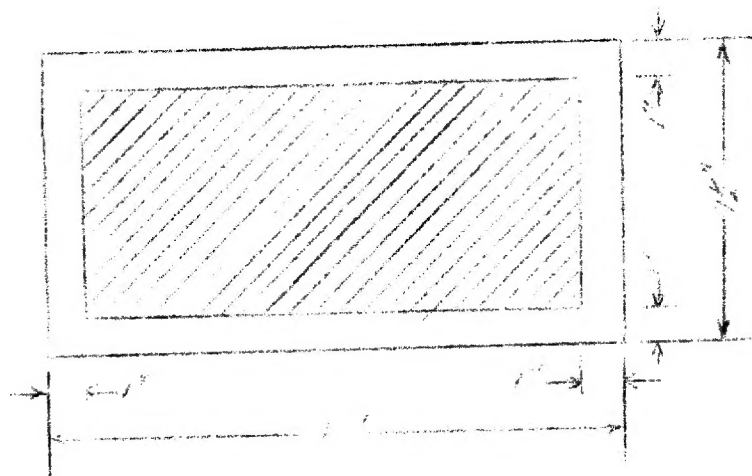
g. The illumination system must provide a maximum illumination of at least 2,000 ft. lamberts within a 2" radius of the geometric center of the illuminated area. The maximum linear brightness gradient must not exceed 15% between any two measurements taken within the shaded area shown on the diagram below, nor 25% anywhere within the illuminated area.
